A case study of urban road subsidence induced by the underground connection of the shield tunnelling method

To cite this article: Y H Chen and H H Pan 2019 *IOP Conf. Ser.: Mater. Sci. Eng.* **615** 012025

Y H Chen¹ and H H Pan^{2,3}

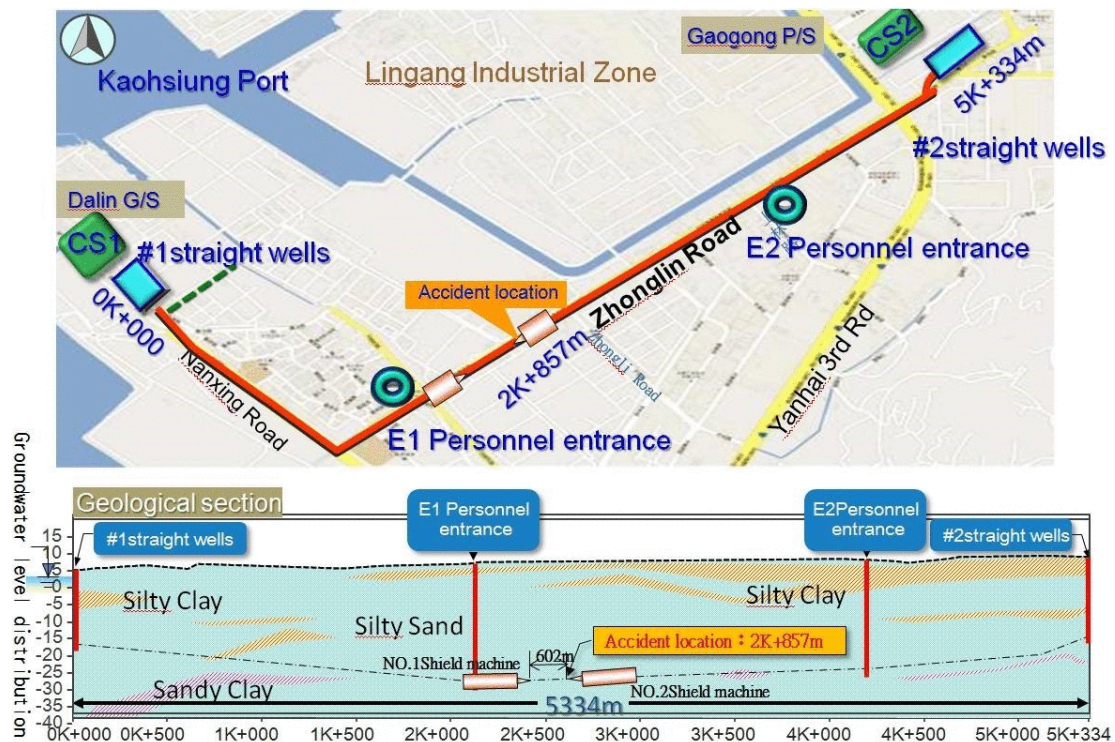
Figure 1. Plan illustration and stratigraphic section of the accident location.

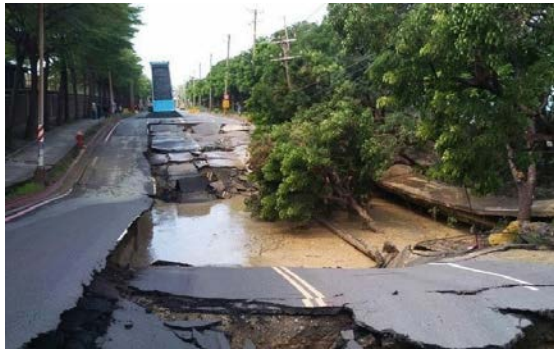
Figure 2. Road subsidence due to subsurface settlement.

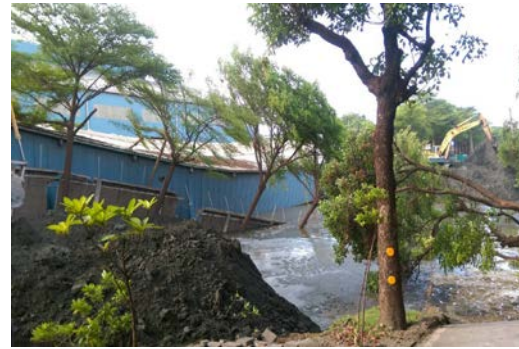
Figure 3. Warehouse subsidence due to subsurface settlement.

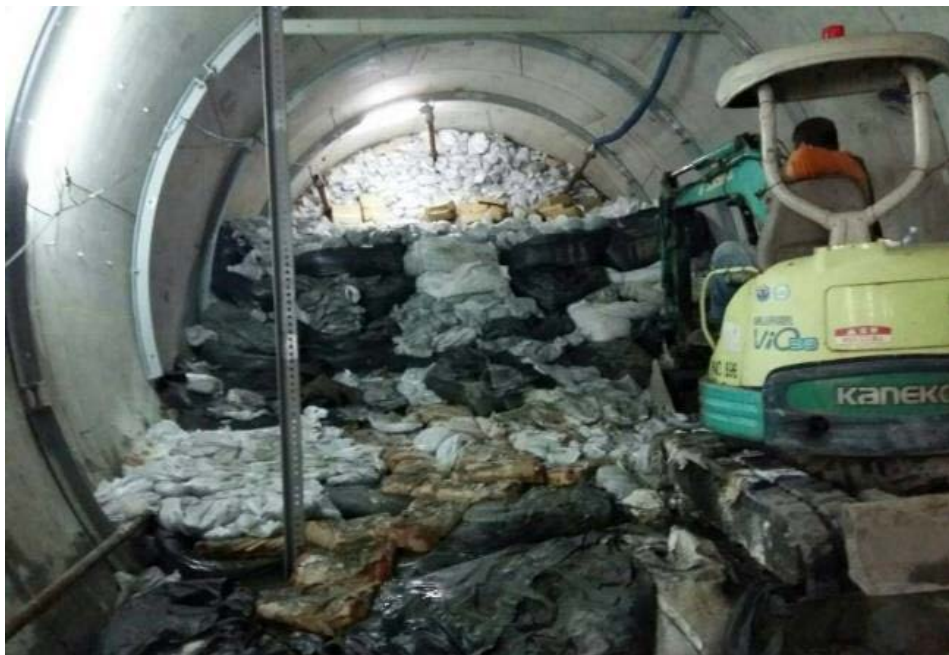
However, mass water and soil continued to flood into the tunnel. Additional emergency measures were taken: 1) sandbags were stacked to stop the water inrush, shown in figure 4, and 2) the hydraulic jacks applied loads to slow down slurry. As large quantity of water gushed out, the local soil under the front shield hollowed. This effect caused the head of shield machine to have a 200 mm subsidence. Then, the back of the connecting shield segment was dragged and began to deform, thus inducing a successive water leakage near the segment joints.

Figure 4. Stacking sandbags to stop water inrush in the tunnel.

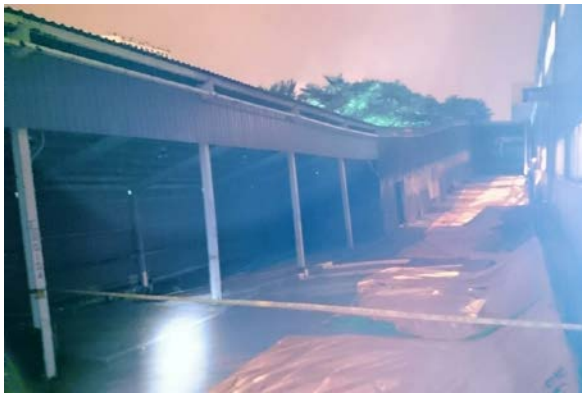
The land subsidence hazard caused a 10-m long and 75-m wide road collapse. Many factory buildings tilted due to the occurrence of alligator cracking on the road, as shown in figures 5 and 6. Moreover, underground pipelines, including telecommunications line, power line, water pipe, sewage pipe, oil pipes, and gas pipes, were damaged. The hazard influenced 4000 power users and 300 water users, and the total loss based on the preliminary estimate was approximately 17 million US dollars.

Figure 5. The CPC warehouse subsided due to the land subsidence hazard.

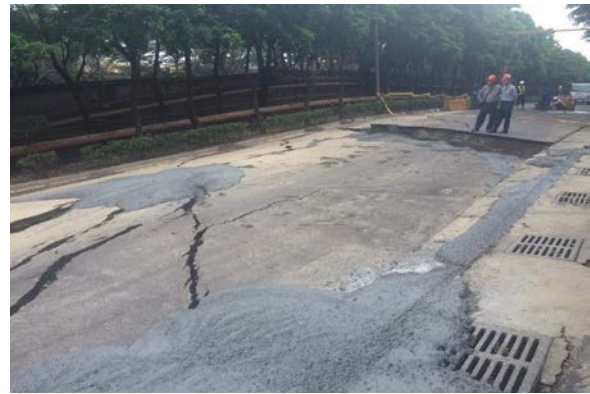
Figure 6. Alligator cracking of the road that occurred due to the land subsidence hazard.

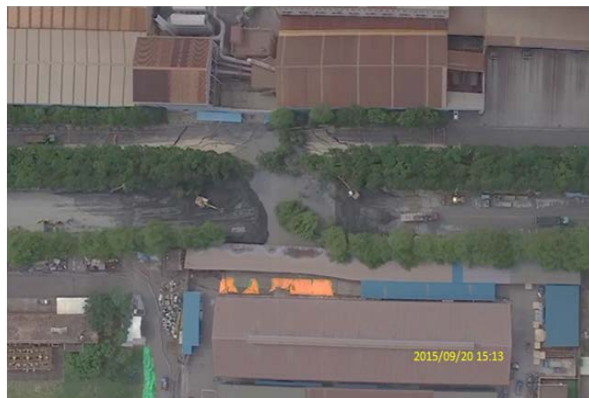
During the period of recovery rescue, aerial photography was used twice a day to manage the hazard-impacted area, and 36 monitoring points were installed at the warehouse of China Steel Corporation (CSC) and Chinese Petroleum Corporation (CPC) near the hazard zone to monitor the change in land subsidence every 2–4 h, as shown in figures 7 and 8.

Figure 7. Aerial photo of the hazard-impacted area of the disaster.

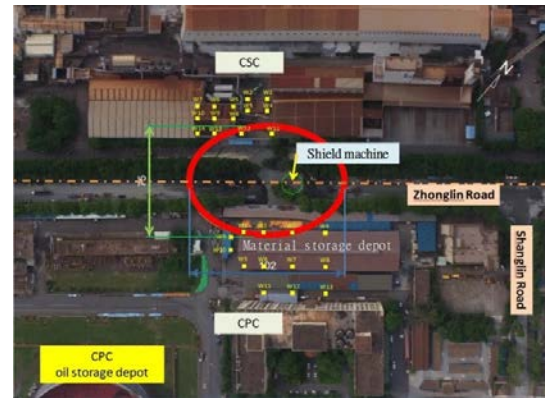
Figure 8. Hazard-impacted area and 36 monitoring points nearby, which include 14 points at the CSC warehouse and 22 points at the CPC warehouse.
