第十三次初階課程授課紀錄

由鐵達尼號看海運科技與
海上人命安全法規的發展
于家成

<p>國立高雄海洋科技大學 海洋科技新貴計畫-船廠經營管理課程</p>   <p>RMS Titanic The Evolutions of International Conventions 由鐵達尼號看海運科技與海上人命安全法規的發展 8 December 2010 法國驗船協會于家成</p>   <p>Move Forward with Confidence</p>	<p>前言</p> <ul style="list-style-type: none"> ▶ Tragedy of RMS Titanic ▶ The reasons for her loss ▶ The lessons learned ▶ Modern cruising vessels ▶ A glance into the Shipping World  
<p>RMS Titanic – the story</p>  	<p>RMS Titanic (1912) – The magnificent ship</p> <ul style="list-style-type: none"> ▶ Owner: White Star Line ▶ Type: Olympic-class ocean liner (<i>Olympic, Titanic, Britannic</i>) ▶ Builder: Harland and Wolf yards, Belfast, Ireland ▶ Length of all: 269.1 m ▶ Breadth: 28.2 m ▶ Height: 18 m above water line ▶ Draft: 10.5 m ▶ Power: 59,000 hp 24+5 boilers, 2 x four-cylinder triple expansion reciprocating engines (215 psi, 15,000 hp each, 75 rpm) for 2 wing propellers (3 blades), 1 x low pressure (9 psi) steam turbine 16,000 hp for center propeller (4 blade) ▶ Speed: 21 knots (max. 23 knots) ▶ Capacity: 3,547 (passengers+officers+crew) ▶ Tonnage: 46,328 GT ▶ Displacement: 52,310 tons

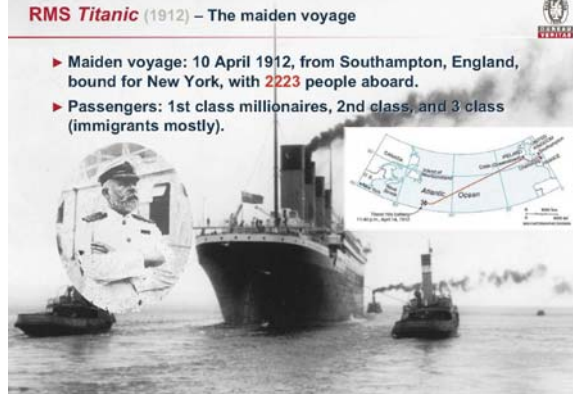
<p>RMS Titanic (1912) – The design</p> <ul style="list-style-type: none"> ▶ The biggest, and most luxurious ship at the time ▶ Hull: "practically unsinkable" <ul style="list-style-type: none"> • Steel hull, riveted • Double bottom, 6 water-tight decks, 16 watertight bulkheads ▶ Propulsion, 3 x screw propellers ▶ Electrical lighting ▶ Lifeboat: 16 wooden x 65 persons + 4 collapsible x 47 persons (1228 persons, abt. 52%), total 20 boats <ul style="list-style-type: none"> • British Regulation: 16 boats minimum (50% capacity) according to the gross tonnage (> 10,000).  	<p>RMS Titanic (1912) – The maiden voyage</p> <ul style="list-style-type: none"> ▶ Maiden voyage: 10 April 1912, from Southampton, England, bound for New York, with 2223 people aboard. ▶ Passengers: 1st class millionaires, 2nd class, and 3 class (immigrants mostly).

皇家所給予的頭銜，當擁有 RMS 的頭銜，表示這是英國皇家所給予這艘船可以載運皇家的郵件，主要由 Cumard 公司負責，而 White Star 公司也想要投入 RMS 的領域，當他投入這個領域的時候就希望比 Cumard 還要強大，因此開始規劃三艘 Olympic、Titanic、Tiganteanic 的豪華郵輪，但當第二艘 Titanic 沈船後將 Tiganteanic 改名為 Britannic，Olympic 與 Titanic 屬同型船的姊妹船，不一樣的是他裝潢比較漂亮，建造廠是在愛爾蘭的 Harland 船廠，船長 269.1m，船寬 28.2 米，水線以上高 18 米，吃水 10.5 米，馬力有 5900 匹，有 29 個 boiler，2 個四衝程往覆式引擎，一台 steam turbine，有三個推進系統帶動三個 propeller，在左右舷各有一個 propeller，船中有一個 propeller，船速 21 節，最高可達 23 節，船上可容納 3547 人，Tonnage 為 46328 公噸，排水量 52310 噸。外觀上它具有 4 個煙囪，但實質上他只有三個機艙，所以有個煙囪是為了外觀上的需求而裝設的。在當時鐵達尼確實為最大最豪華的船舶，在剛開始的故事中，有人認為他們太自傲，認為他們的船是不會沈的，但事實上他們的說法是『Practically Unsinkable』，這也是相當自負的說法，如此大的船是不會沈的，設計是安全的，並且不會沈。此船以鋼板為建材，鋼板以鉚接方式連接，具有雙層底，六層水密夾板，16 道的水密隔艙，安全性來說是相當強的，具有三個 propeller，左右兩個加中間一個，最後一個是舵，此船也是第一個全船使用電燈的船舶，在這之前都是使用煤油燈，此外，本艘船備有 16 艘木製救生艇，每艘可以承載 65 人，4 艘可折疊式的救生艇，每艘可承載 47 人，全數加總可以容納 1128 人，相當於全船額訂的百分之 52，這其實是符合當時的英國法規，以當時英國法規而言，一萬噸以上的船舶最少需要 16 艘救生艇，要超過 50% 以上的人員配額。
