第八次初階課程授課紀錄

由鐵達尼號看海運科技與
海上人命安全法規的發展
于家成

國立高雄海洋科技大學
海洋科技新貴計畫-船廠經營管理課程

The Evolutions of International Conventions
由鐵達尼號看海運科技與海上人命安全法規的發展

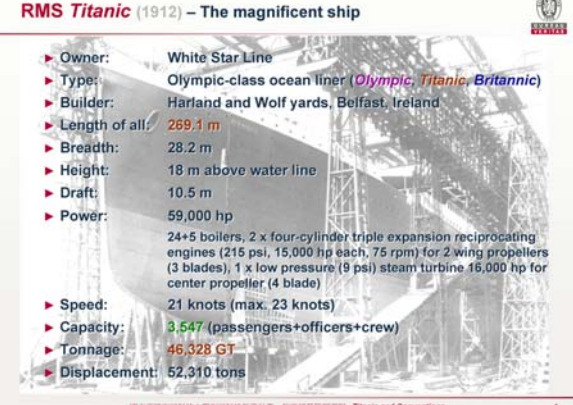
RMS Titanic (1912) – The magnificent ship

- ▶ Owner: White Star Line
- ▶ Type: Olympic-class ocean liner (*Olympic, Titanic, Britannic*)
- ▶ Builder: Harland and Wolf yards, Belfast, Ireland
- ▶ Length of all: 269.1 m
- ▶ Breadth: 28.2 m
- ▶ Height: 18 m above water line
- ▶ Draft: 10.5 m
- ▶ Power: 59,000 hp
24+5 boilers, 2 x four-cylinder triple expansion reciprocating engines (215 psi, 15,000 hp each, 75 rpm) for 2 wing propellers (3 blades), 1 x low pressure (9 psi) steam turbine 16,000 hp for center propeller (4 blade)
- ▶ Speed: 21 knots (max. 23 knots)
- ▶ Capacity: 3,547 (passengers+officers+crew)
- ▶ Tonnage: 46,328 GT
- ▶ Displacement: 52,310 tons

鐵達尼號是 1912 年的船，在那個時代也是最豪華的一艘船，但不是最大、最快的船，可是絕對是最壯麗的船，他的 owner 是 White Star (白星公司)，是在越洋航線的新comer，過去比較有名的是 Cunard，這是到今天仍然存在的公司，是營運歐洲大陸到北美之間的越洋航線，這時代的船大部分都是客貨兩用船，如果是比較高級的船，貨物的裝載就不是那麼的重要了；當時 White Star 跟 Cunard 競爭時，就想要建造比 Cunard 更豪華的船，基本上經營一個航線必須要有三艘船，於是開始計畫建造三艘船，而鐵達尼號不是第一艘，第一艘為 Olympic，第二艘為 Titanic，第三艘為 Gigantic (後改為 Britannic)，Olympic 比 Titanic 早一年交船，這三艘雖然是同系列船舶，但是鐵達尼號的內裝比 Olympic 更加豪華，建造是在愛爾蘭的 Belfast Harland and Wolf 船廠，船長 269.1m，船寬 28.2 米，水線以上高 18 米，吃水 10.5 米，馬力有 5900 匹，有 29 個 boiler，2 個四衝程往覆式蒸氣機，每一個帶動一個 propeller，左、右舷各有一個 propeller 是由往覆式蒸汽機帶動，中間有一個 propeller 是由低壓的 steam turbine 帶動，船速 21 節，最高可達 23 節，船上可容納 3547 人，Tonnage (容積) 為 46328 公噸，排水量 52310 噸。在當時鐵達尼確實為最大、最豪華的船舶，當時他們沒有說他們是『Unsinkable』的船，但事實上他們的說法是『Practically Unsinkable』，他們認為已經是做到相當安全的地步了，全船由鋼板建造，鋼板技術是
