The Nondestructive Evaluation of High-Temperature Conditioned Concrete in conjunction with Acoustic Emission and X-ray Computed Tomography

Yu-Min Su^{*a}, Tsung-Chin Hou^b, Li-Chiang Lin^c, Gwan-Ying Chen^a, Huang-Hsing Pan^a
^a Department of Civil Engineering/National Kaohsiung University of Applied Sciences, 415 Chien-Kung Ed., Sanmin, Kaohsiung 80778, Taiwan; ^b Department of Civil Engineering/National Cheng Kung University, 1 University Rd., Tainan, Tainan 70101, Taiwan; ^c E-Da Hospital/I-Shou University, 1 Yi-Da Rd., Jiao-Su Village, Yanchao, Kaohsiung 82445, Taiwan

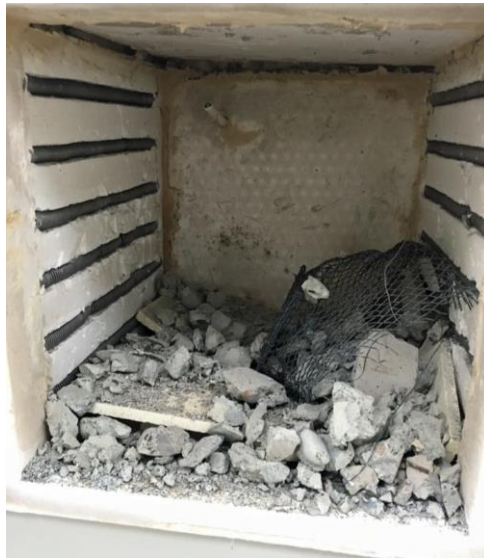
Figure 1. Shattered OPC concrete cylinder with broken protective steel meshes in the furnace (Photo taken by Dr. Yu-Min Su)

After curing process, OPC concrete cylinders were brought to a furnace which is capable of heating up to 900 °C. The initial plan was to wipe out the existing water out of the cylinders and put cylinders immediately to the furnace for elevated temperature treatment. The initial plan for elevating temperature was set-up by the rate of 10 °C/minute. However, the first high-temperature conditioning was a failure and cylinder was exploded and shattered everywhere inside of the chamber of the furnace, shown in Figure 1. The high-temperature conditioning later was revised to leave specimens in the ambient room temperature (approximately 20 to 23-°C and 50 to 70-% in humidity) for one week firstly and later heat up by a lower elevating rate by 3 °C/minute, which came to a success to treat concrete cylinders up to 400 and 600-°C. When the furnace reaches to 400 and 600-°C, the furnace sustains for one hour. After the high-temperature conditioning and cool down process, visual inspections were explicitly executed on the full as well as the sliced cross-section concrete cylinders to identify the surface color changes and cracks. The “fire-damaged” concrete specimens were later brought to a recovery process, either air or moist-curing for another ten days. It has to be noted that the loss of shattered concrete cylinders resulted insufficient concrete specimens for the proposed task of conducting the acoustic emission coupling with splitting tensile strength test. Another supplementary OPC concrete mixing, casting, and curing job has undergone and acoustic emission associated with splitting tensile testing will be conducted in the next phase of the research.

- Due to the cylinders exploded and shattered in the chamber of the furnace, it was unable to complete the task proposed to utilize acoustic emission with the splitting tensile test. New concrete mix has proportioned and this unfinished task can be added to next phase of the research work.

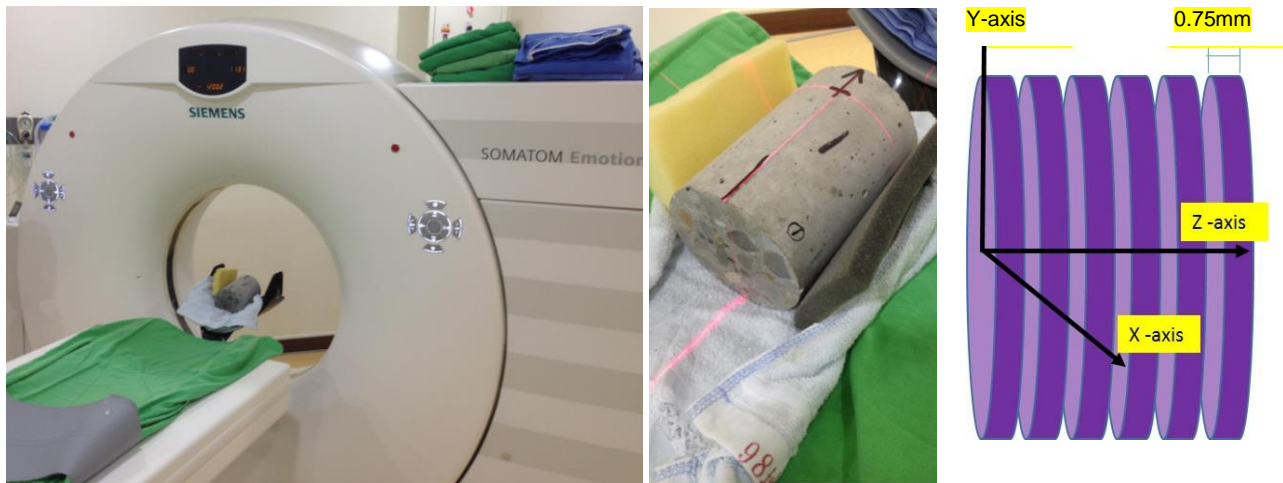
Figure 2. X-ray CT facility, the focus of the concrete cylinder while inserting for nondestructive CT scanning, and the orientation of the virtual segments (Photos taken by Dr. Yu-Min Su)

The nondestructive evaluation through the medical X-ray CT was conducted at the E-Da/I-Shou University Hospital. The Somatom® Emotion manufactured by the Siemens Healthcare is a 16-channel X-ray CT facility and provides maximum 0.75 mm in resolution in Z-axis. Figures 2 presents the X-ray CT facility, the focus of the concrete cylinder, and the orientation of the virtual segments. While performing the X-ray CT scan, the concrete cylinder was placed on the patient’s table. The operator positioned the table properly and started the scan. The concrete cylinder was going

back and forth through the ring of the facility along with the Z-axis and the embedded sixteen X-ray channels/sources acquired multiple X-ray digital images to construct the three-dimensional reconstruction momentarily. The setting of acquiring the concrete cylinder CT images was to use 110kV with automatic current (mA/ μ A). Previously NDE research work^[8] conducted have identified and adopted setting with the same voltage and automatic current during to scan PCC or asphalt concrete without any problem. After the segments acquired from the facility, series of segments in the medical formatting of DIACOM were brought back to KUAS to proceed the image processing and analysis. It has to be noted that the image processing and analysis were conducted by Mathworks MATLAB R2015b and the ImageJ provided by National Institutes of Health. The goal was to quantitatively evaluate the voids area and ratio of each segments and then conduct a topdown and in-depth voids distribution along the Z-axis. X-ray CT scan was employed to concrete cylinders at “before” and “after” high-temperature conditioning as well as after ten-day of the recovery process. Ultimately, it was to distinguish various voids distributions and determine whether or not the “fire/high-temperature” cause the changes of internal voids and the recovery process heal the voids/cracks.

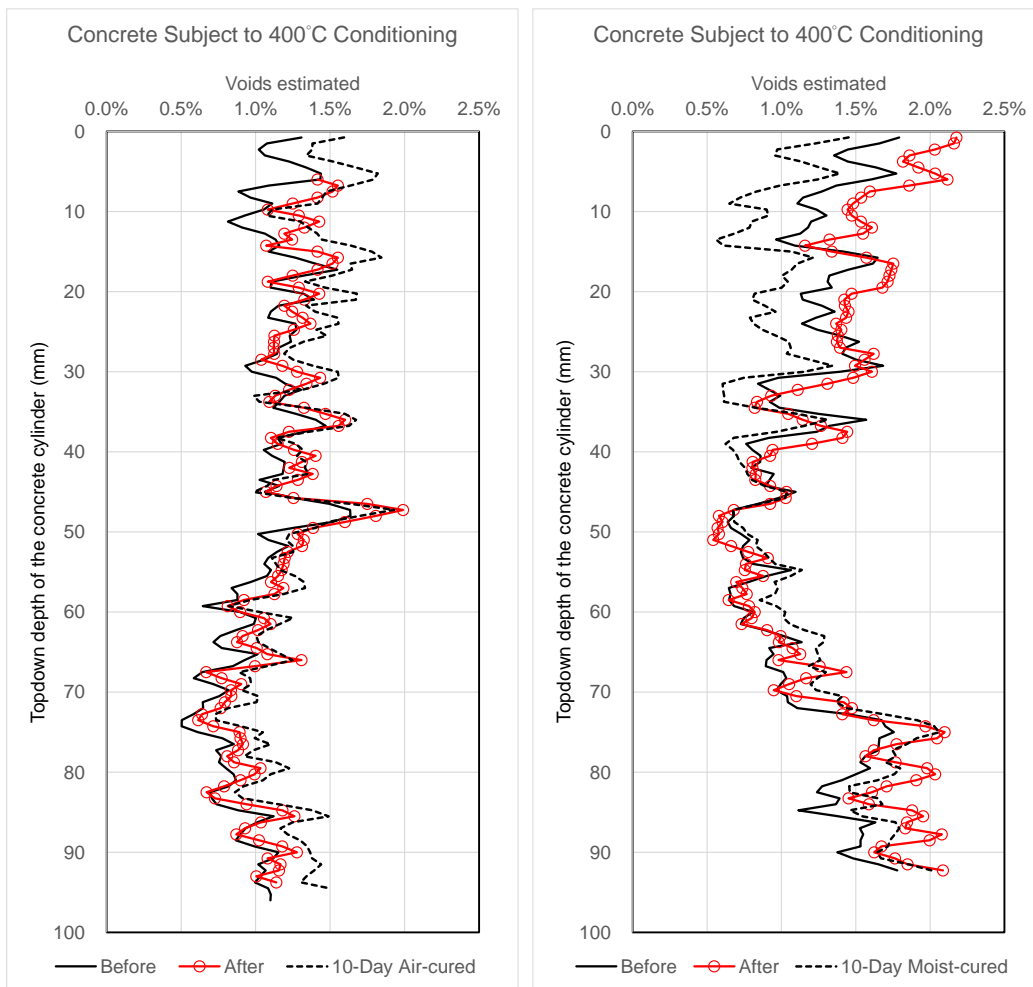
Figure 6. Quantitative voids distribution of concrete cylinders subject to (A) 400°C with air-curing; (B) 400°C with moist-curing; (modified by Dr. Yu-Min Su)

A quantitative analysis in voids distribution conducted with Mathworks MATLAB were established to calculate the estimated voids area and used that to estimate the ratio of the voids in comparison with the overall cross-sectional area of each segment. Figure 6 (A)&(B) showed voids estimated versus topdown depth of the concrete cylinders subject to 400°C with either air or moisture-curing and Figure 7(A)&(B) plotted voids estimated versus topdown depth of the concrete cylinders subject to 400°C with either air or moisture-curing

Figure 6 (A) indicated that the voids of concrete subject to 400°C increased only a few, while the following recovery process with air-curing did not remedy the voids much; Figure 6(B) showed a similar tendency in the lower part of the specimen that the recovery process did not help much. However the upper part of specimen indicated otherwise that the moisture curing did help remedy voids significantly. Figure 7 (A) indicated that the voids of concrete subject to 600°C increased not much but larger than that of 400°C, while the following recovery process with air-curing did not remedy the voids much either; however, Figure 7(B) showed a clear tendency of moisture curing largely help reduce voids. In many segments, it filled (or healed) up to 2% of voids

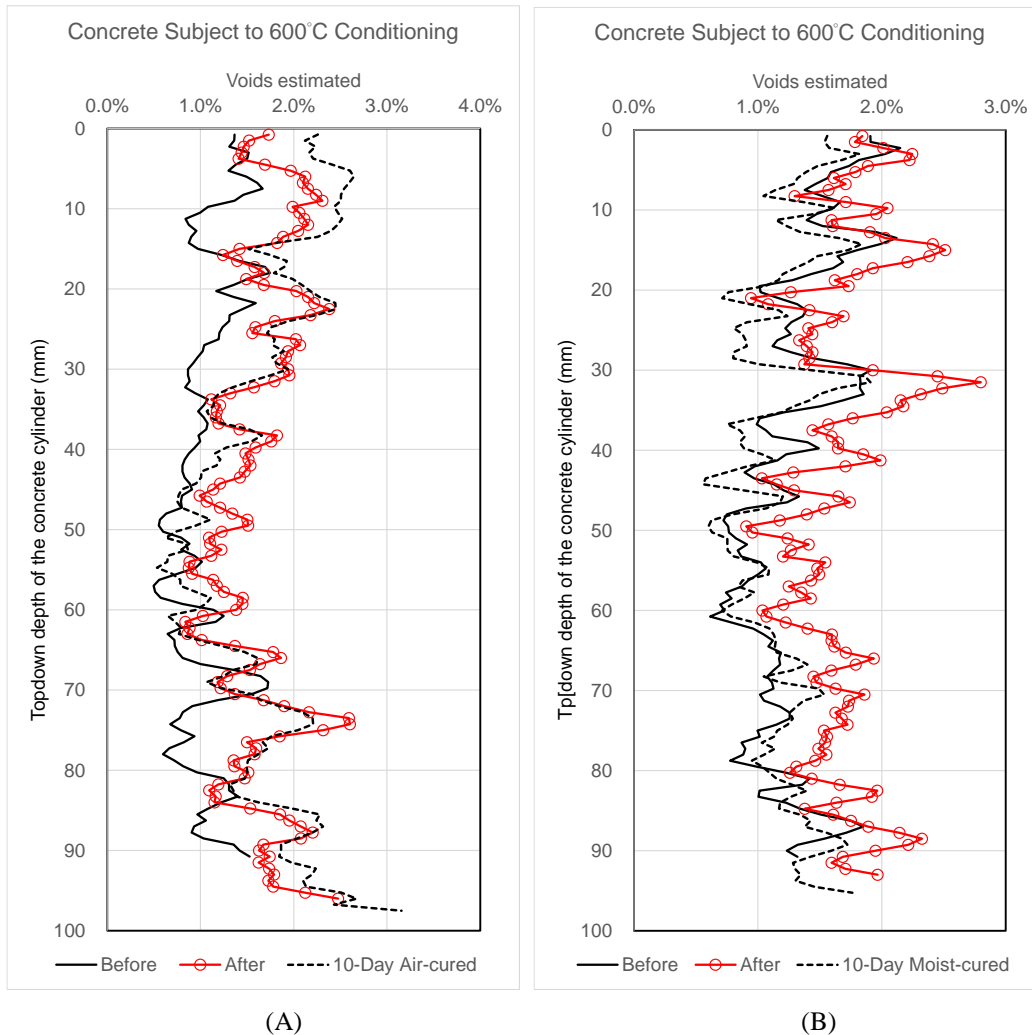
Figure 7. Quantitative voids distribution of concrete cylinders subject to (A) 600°C with air-curing; (B) 600°C with moist-curing; (modified by Dr. Yu-Min Su)

- A quantitative voids distribution approach was established to plot voids distribution versus topdown depth of concrete cylinder with Mathwork MATLAB. Based on the results of voids distribution, not many voids were generated due to the 400°C conditioning, nor significant changes in voids. However, much more voids were appeared due to the 600°C conditioning, and more voids were healed. In many segments, up to 2% of voids were remedied.
